Unlocking the Mystery of Columbia's Tragic Accident Through Materials Characterization

**Presented to
Mississippi State University Materials Working Group**

October 15th, 2003

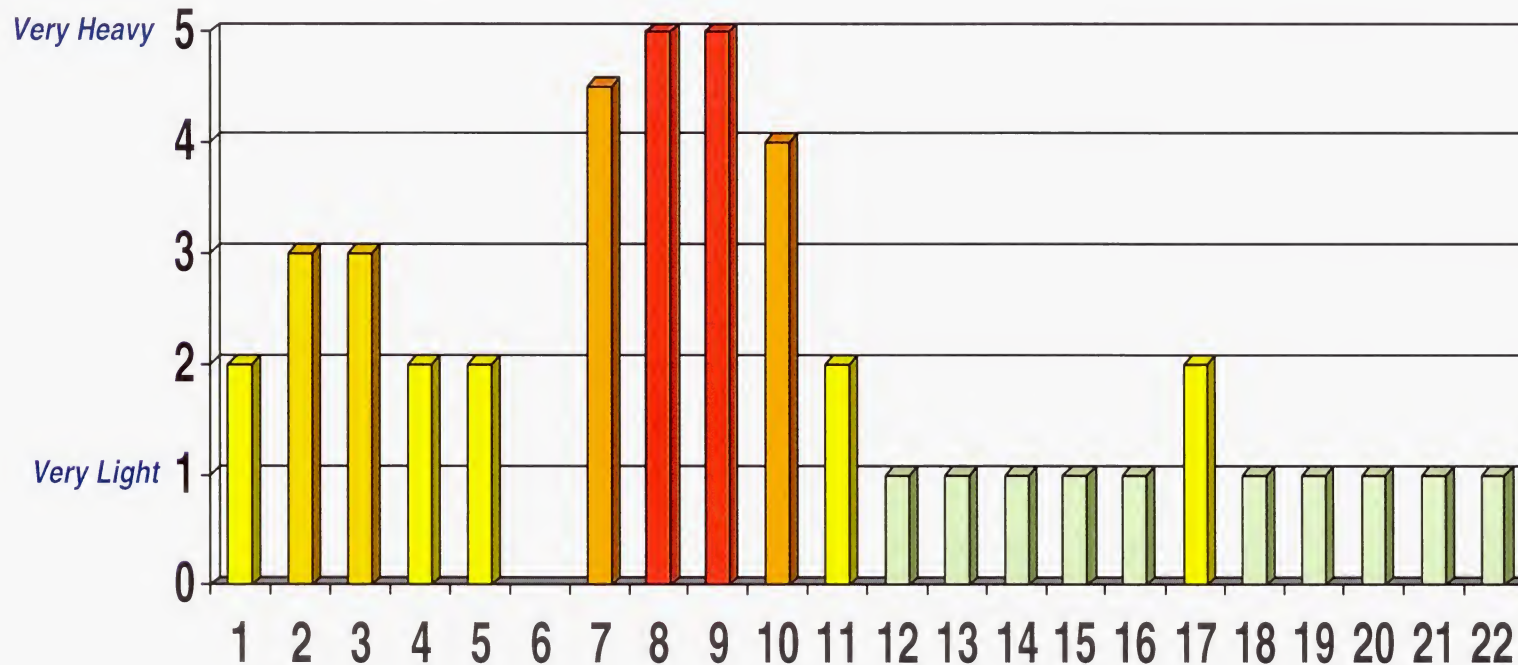
Qualitative Deposition Assessment: “Very Light” to “Very Heavy”

Distribution of “slag” deposition volume
was centered around panels 8 & 9 on Left Wing Leading
Edge RCC.

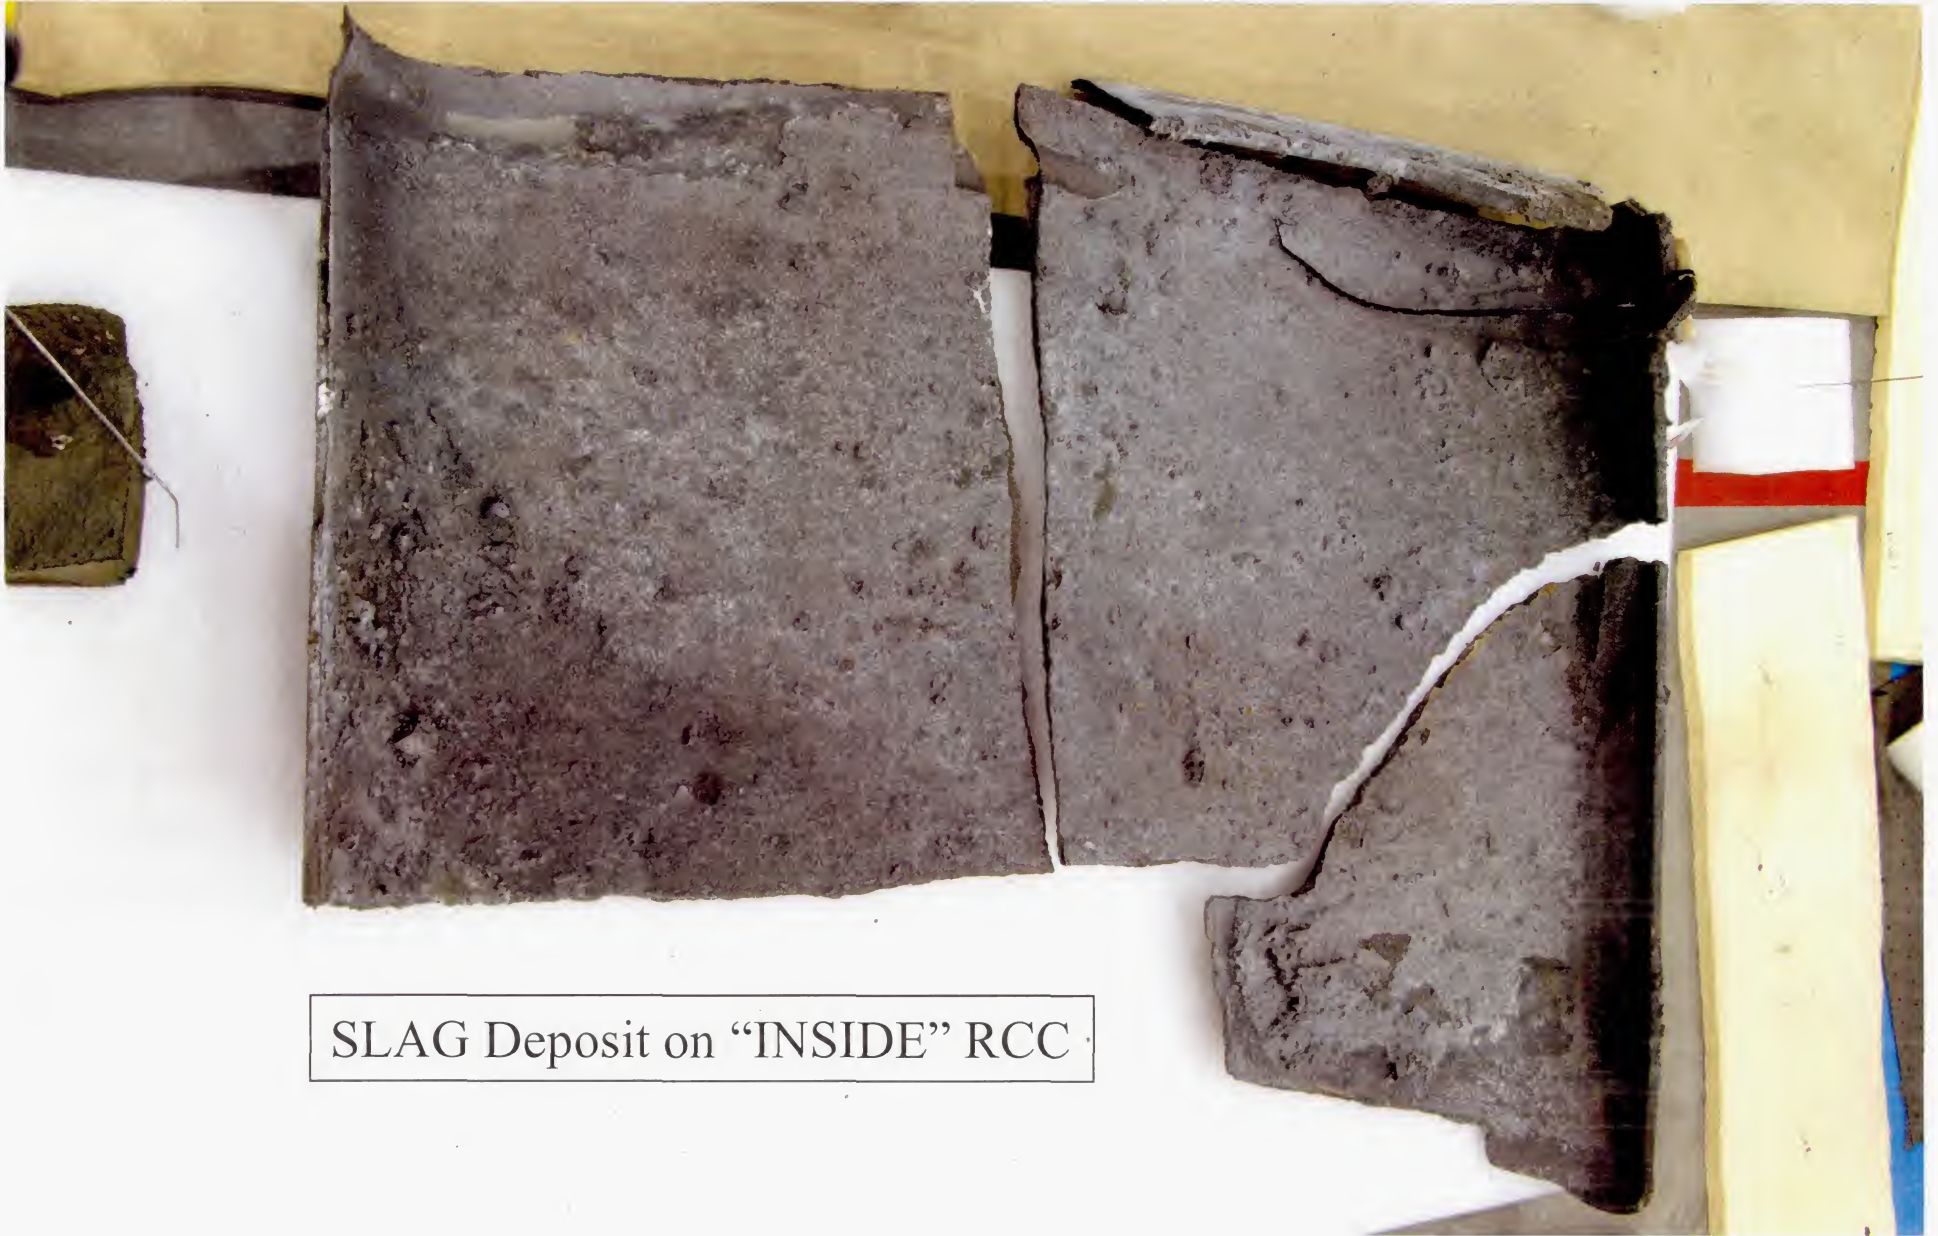
Example Debris, LH RCC 8

SLAG Deposit on "INSIDE" RCC

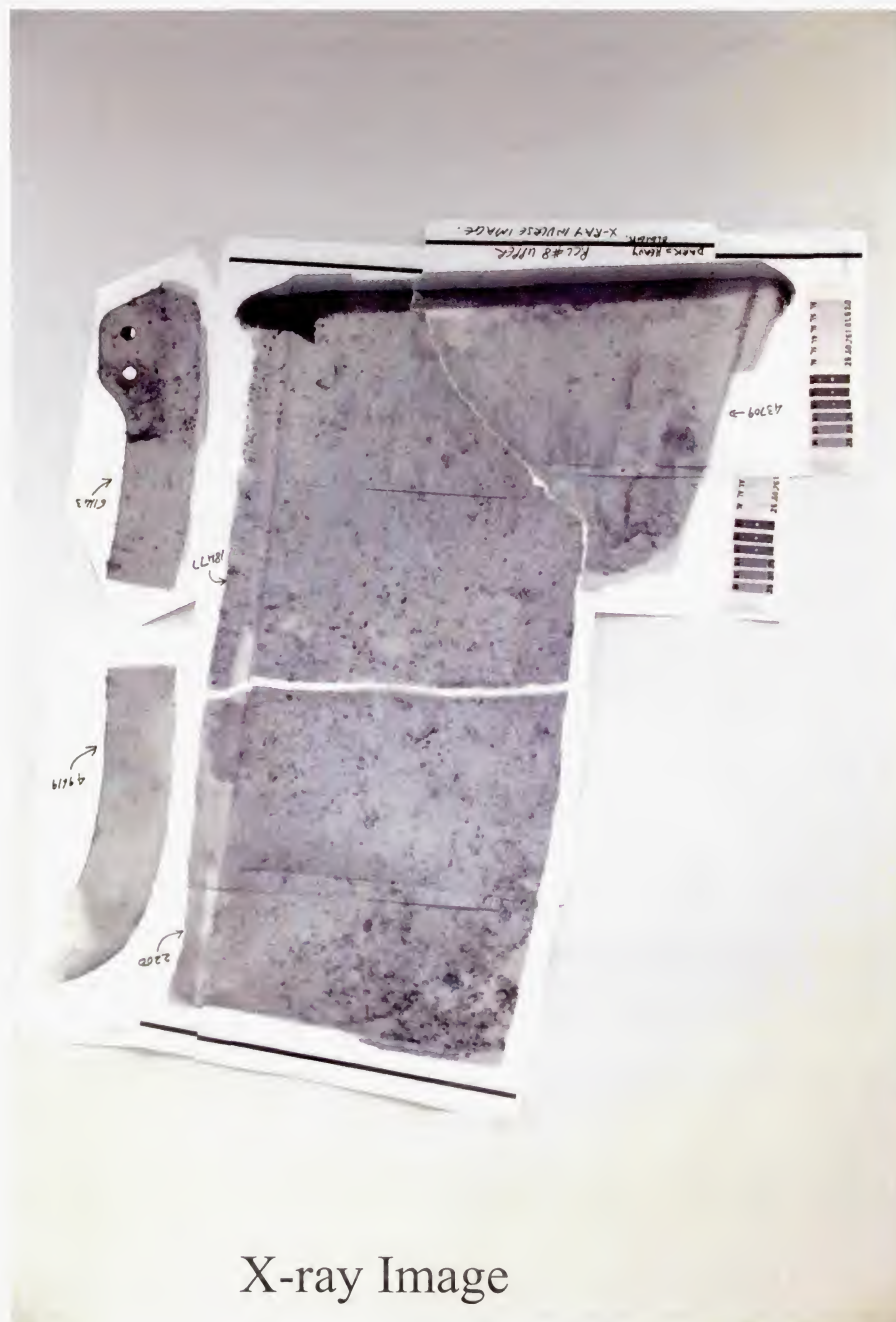
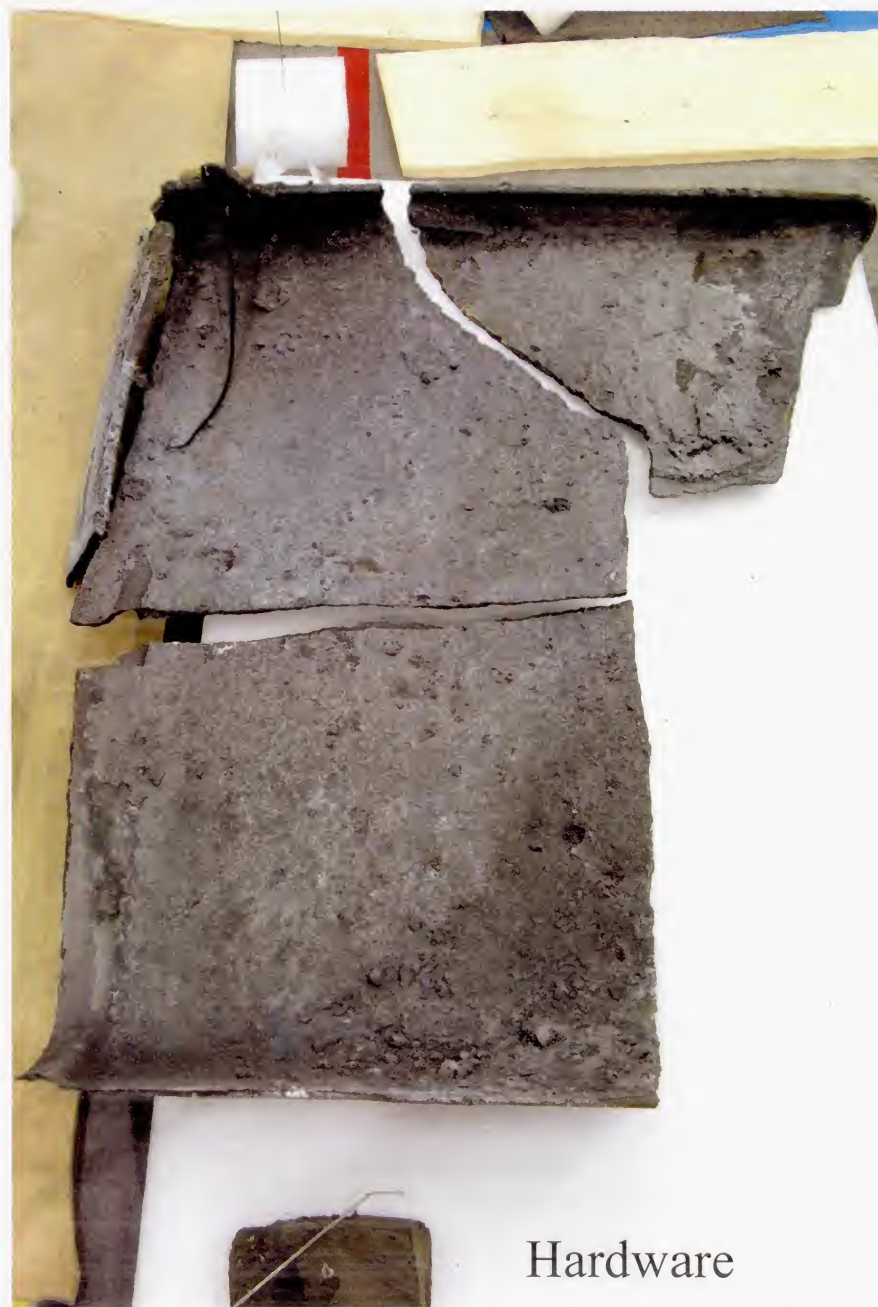
Left Wing RCC panel 8. Inside View.

2200, LH RCC #8 Upper Apex, Part I, Matches 18477

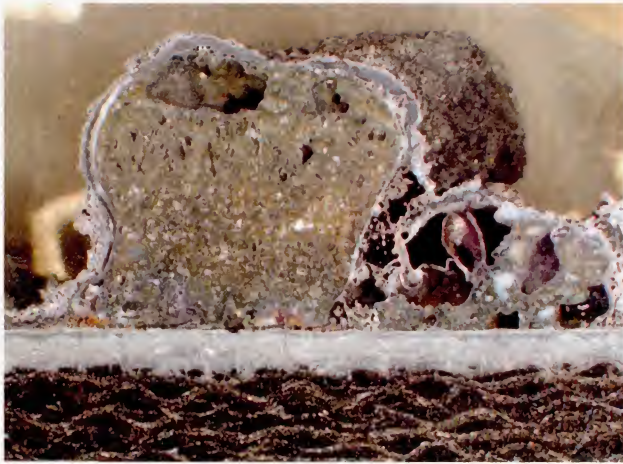
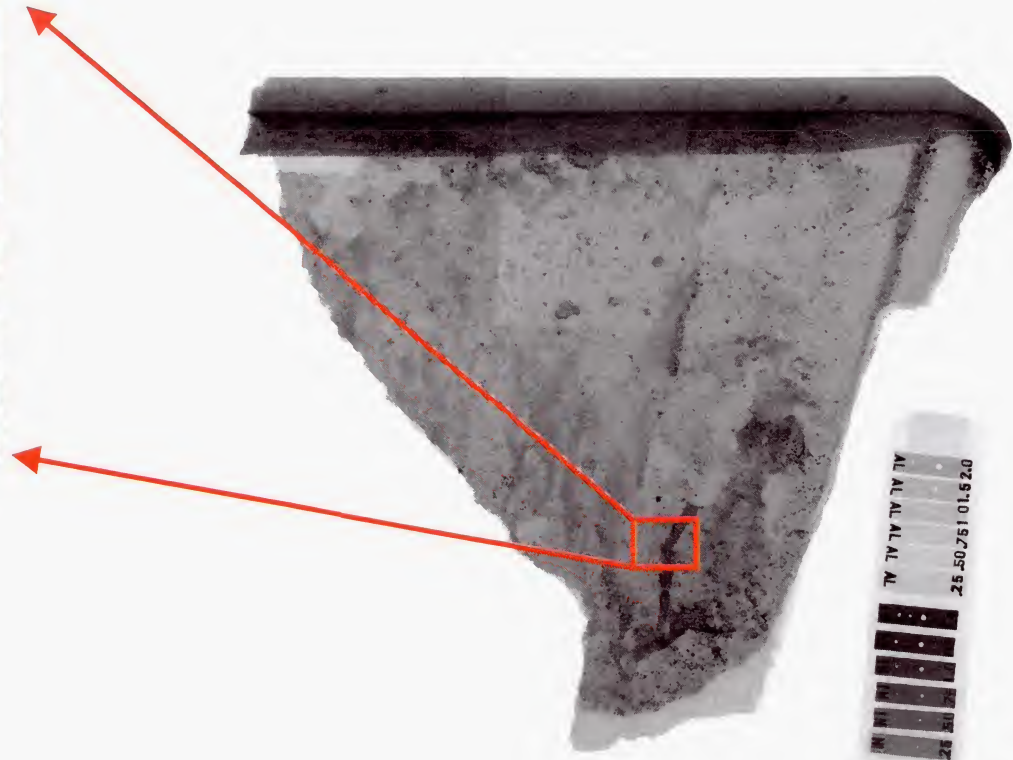
LH RCC #8 - Slag Feature 1

Thick Tear Shaped

Slag Item 43709, Sample 2A1

- Large amounts of melted ceramic cerachrome insulator
 - High temperature $>3200^{\circ}\text{F}$
- No indication of stainless steel spar fittings (A286) in slag
 - Breach location away from spar fittings
- Cerachrome + Inconel in first deposited layers
 - Melting of spanner/foil/fittings + Insulator
- Aluminum deposition secondary event

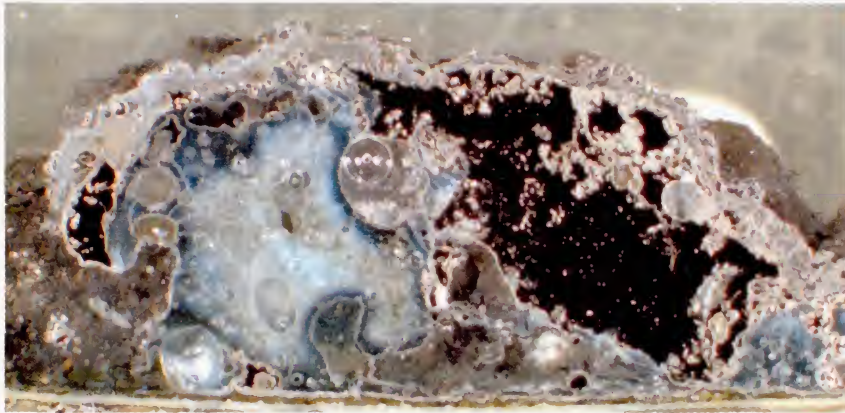
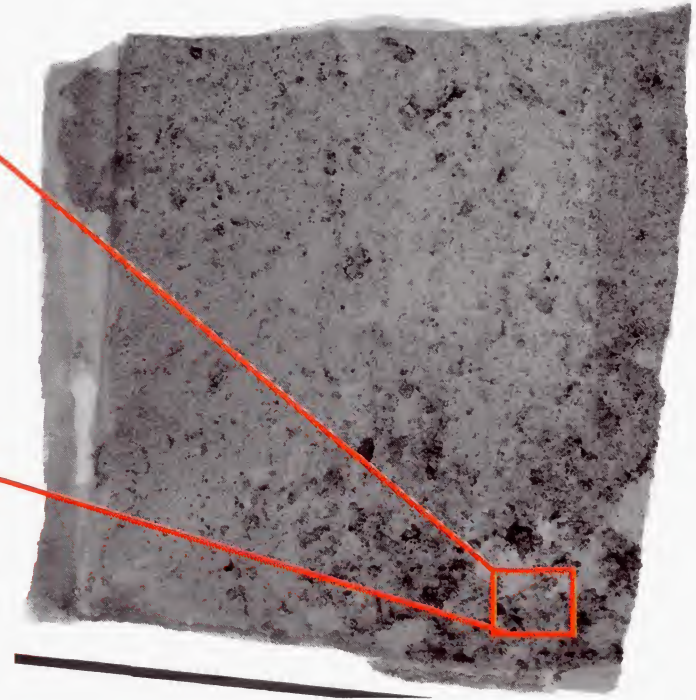
LH RCC #8 - Slag Feature 2

Thick Globules

Slag Item 2200, Sample 6A1

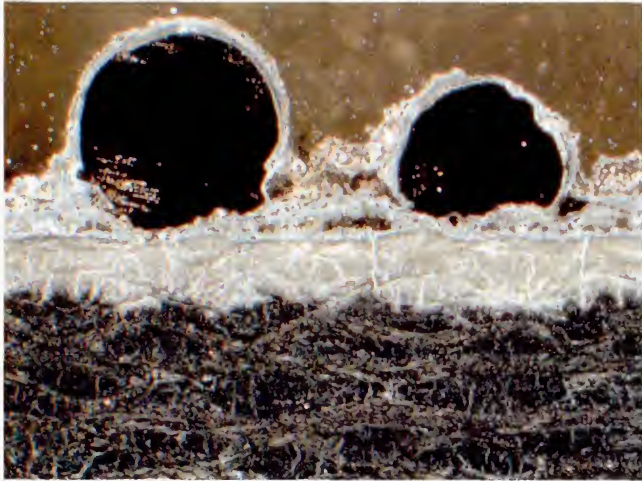
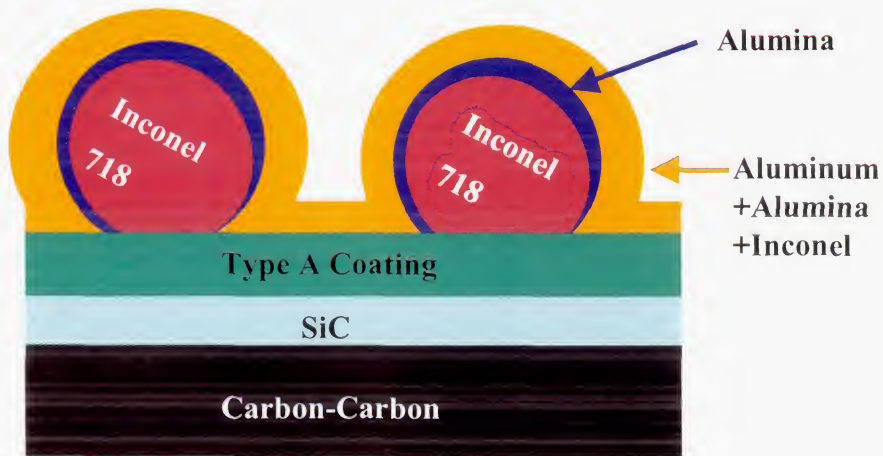
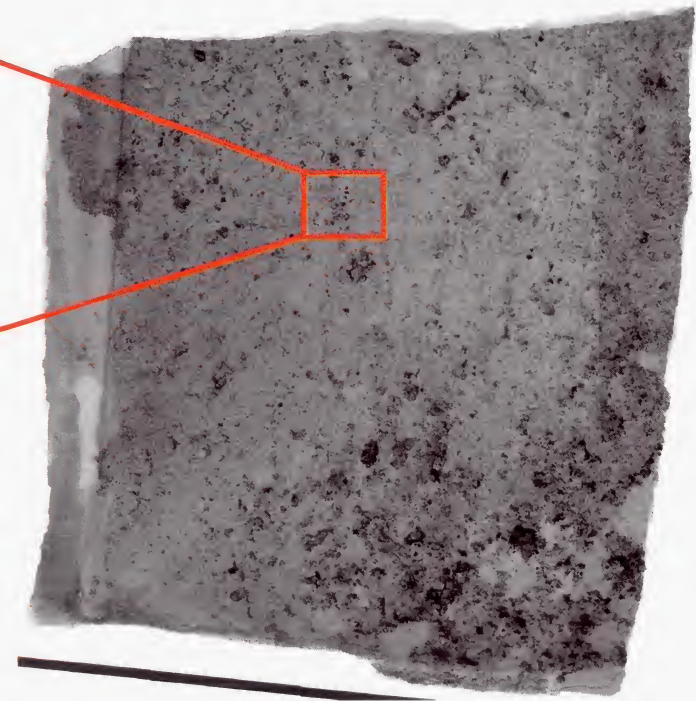
LH RCC #8 - Slag Feature 3 Spheroids

Slag Item 2200, Sample 6C1

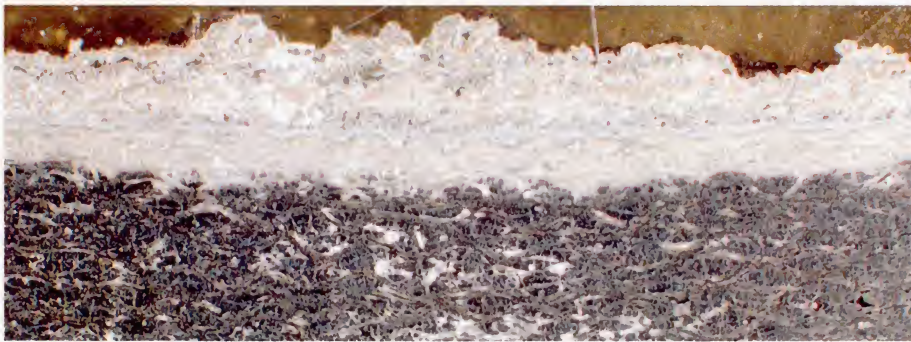
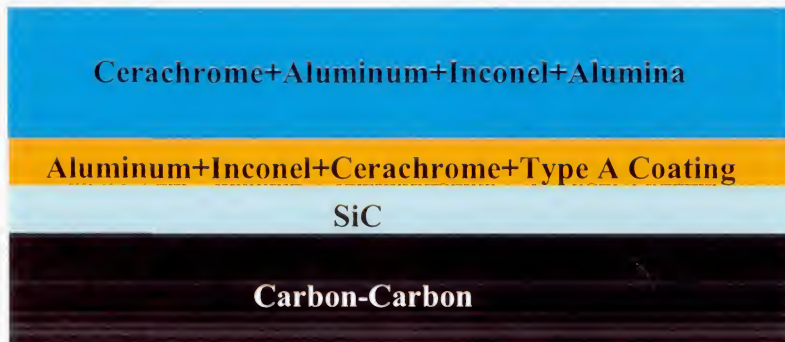
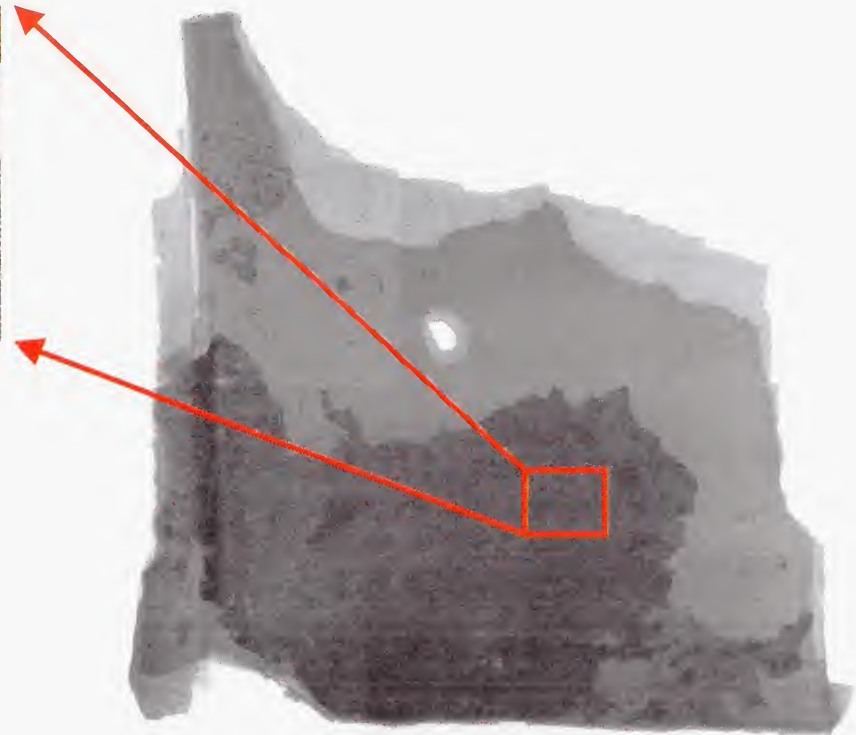
RH RCC #8 - Slag Feature 4

Uniform Deposit

Slag Item 16523, Sample 4A1

- All analyzed slag layers contain aluminum
 - CONCURRENT Spar/Inconel/Insulator melting
- Slag is generally uniform and relatively thin
 - No region where melting was concentrated i.e. plasma heating for short periods

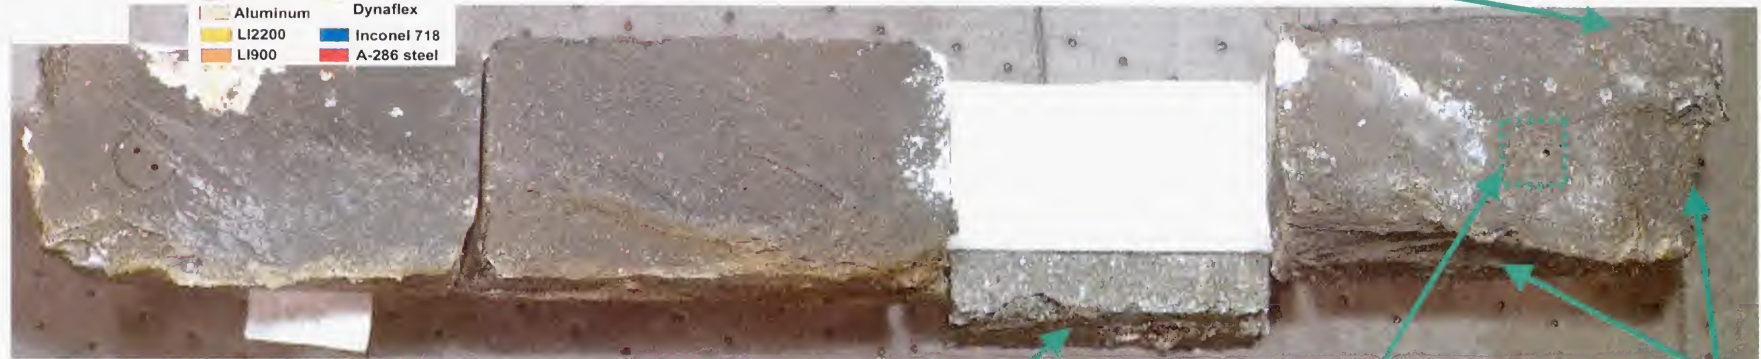
Reconstructed View LH CPanel 9 Tiles, lower

Horse Collar Fabric Deposit

Tile Slumping

Molten Slag on Tile

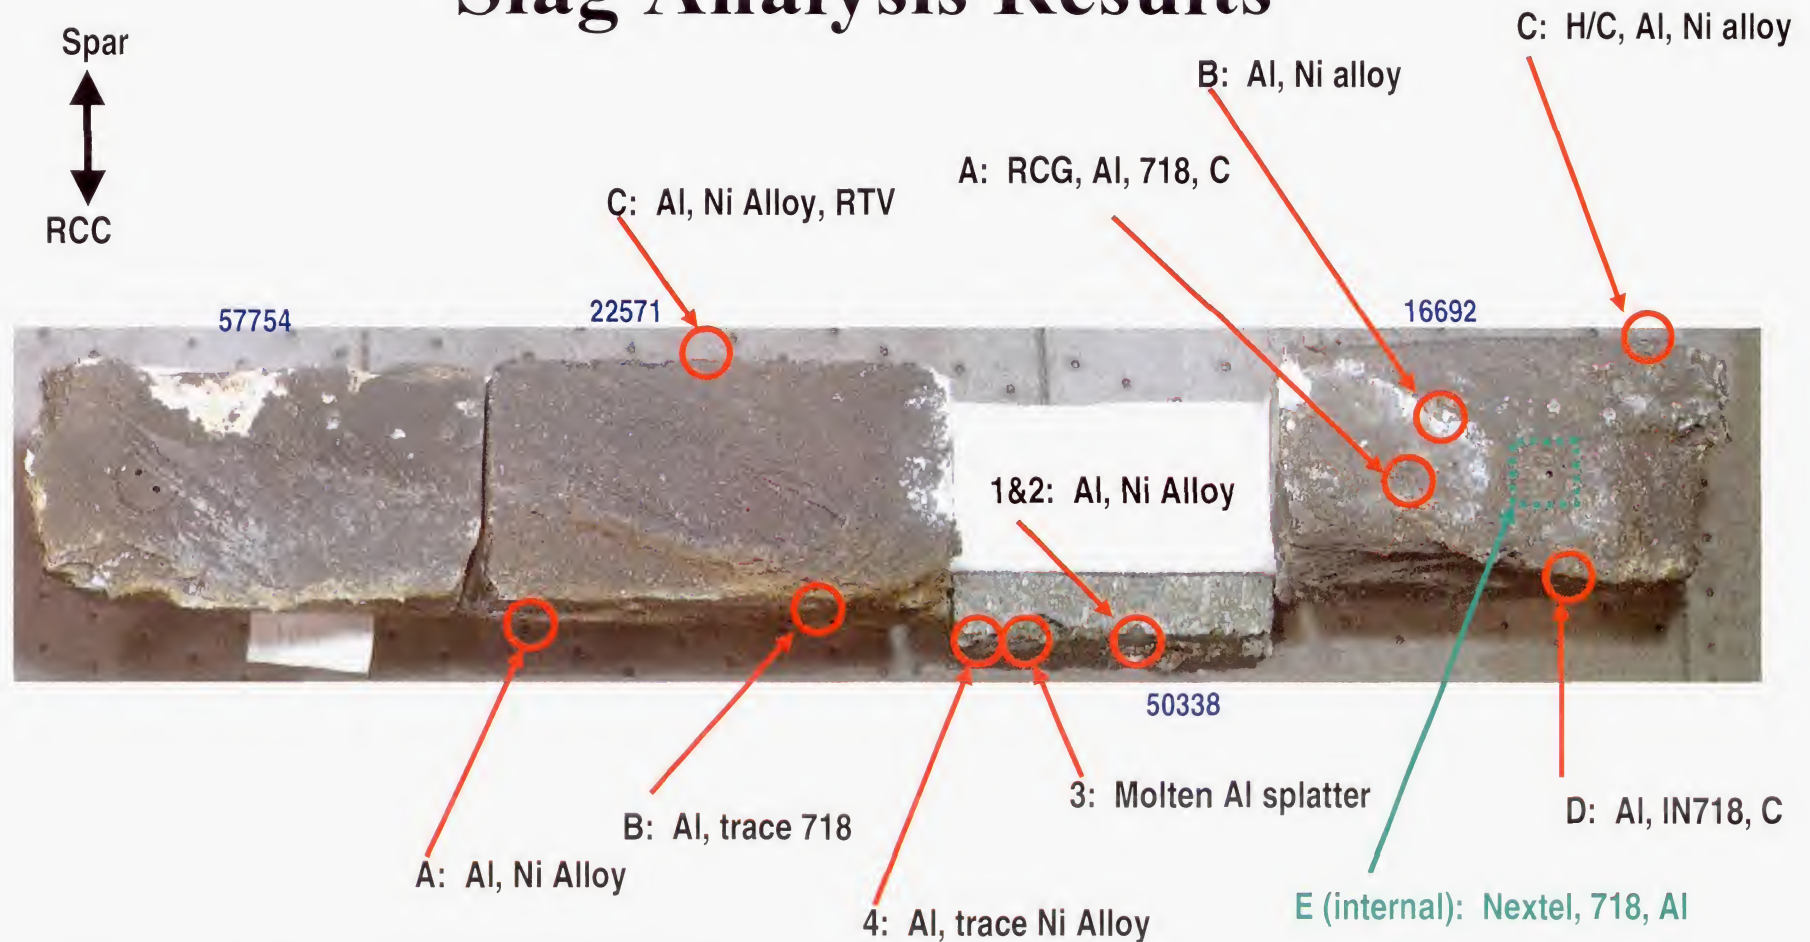
Reconstructed View LH Carrier Panel 9 Tiles, Lower Slag Analysis Results

These findings suggest flow of material from inside the RCC out through the upper and lower CP locations.
